THE PROPOSED SOLUTION

THE CONSTRUCTION PLAN

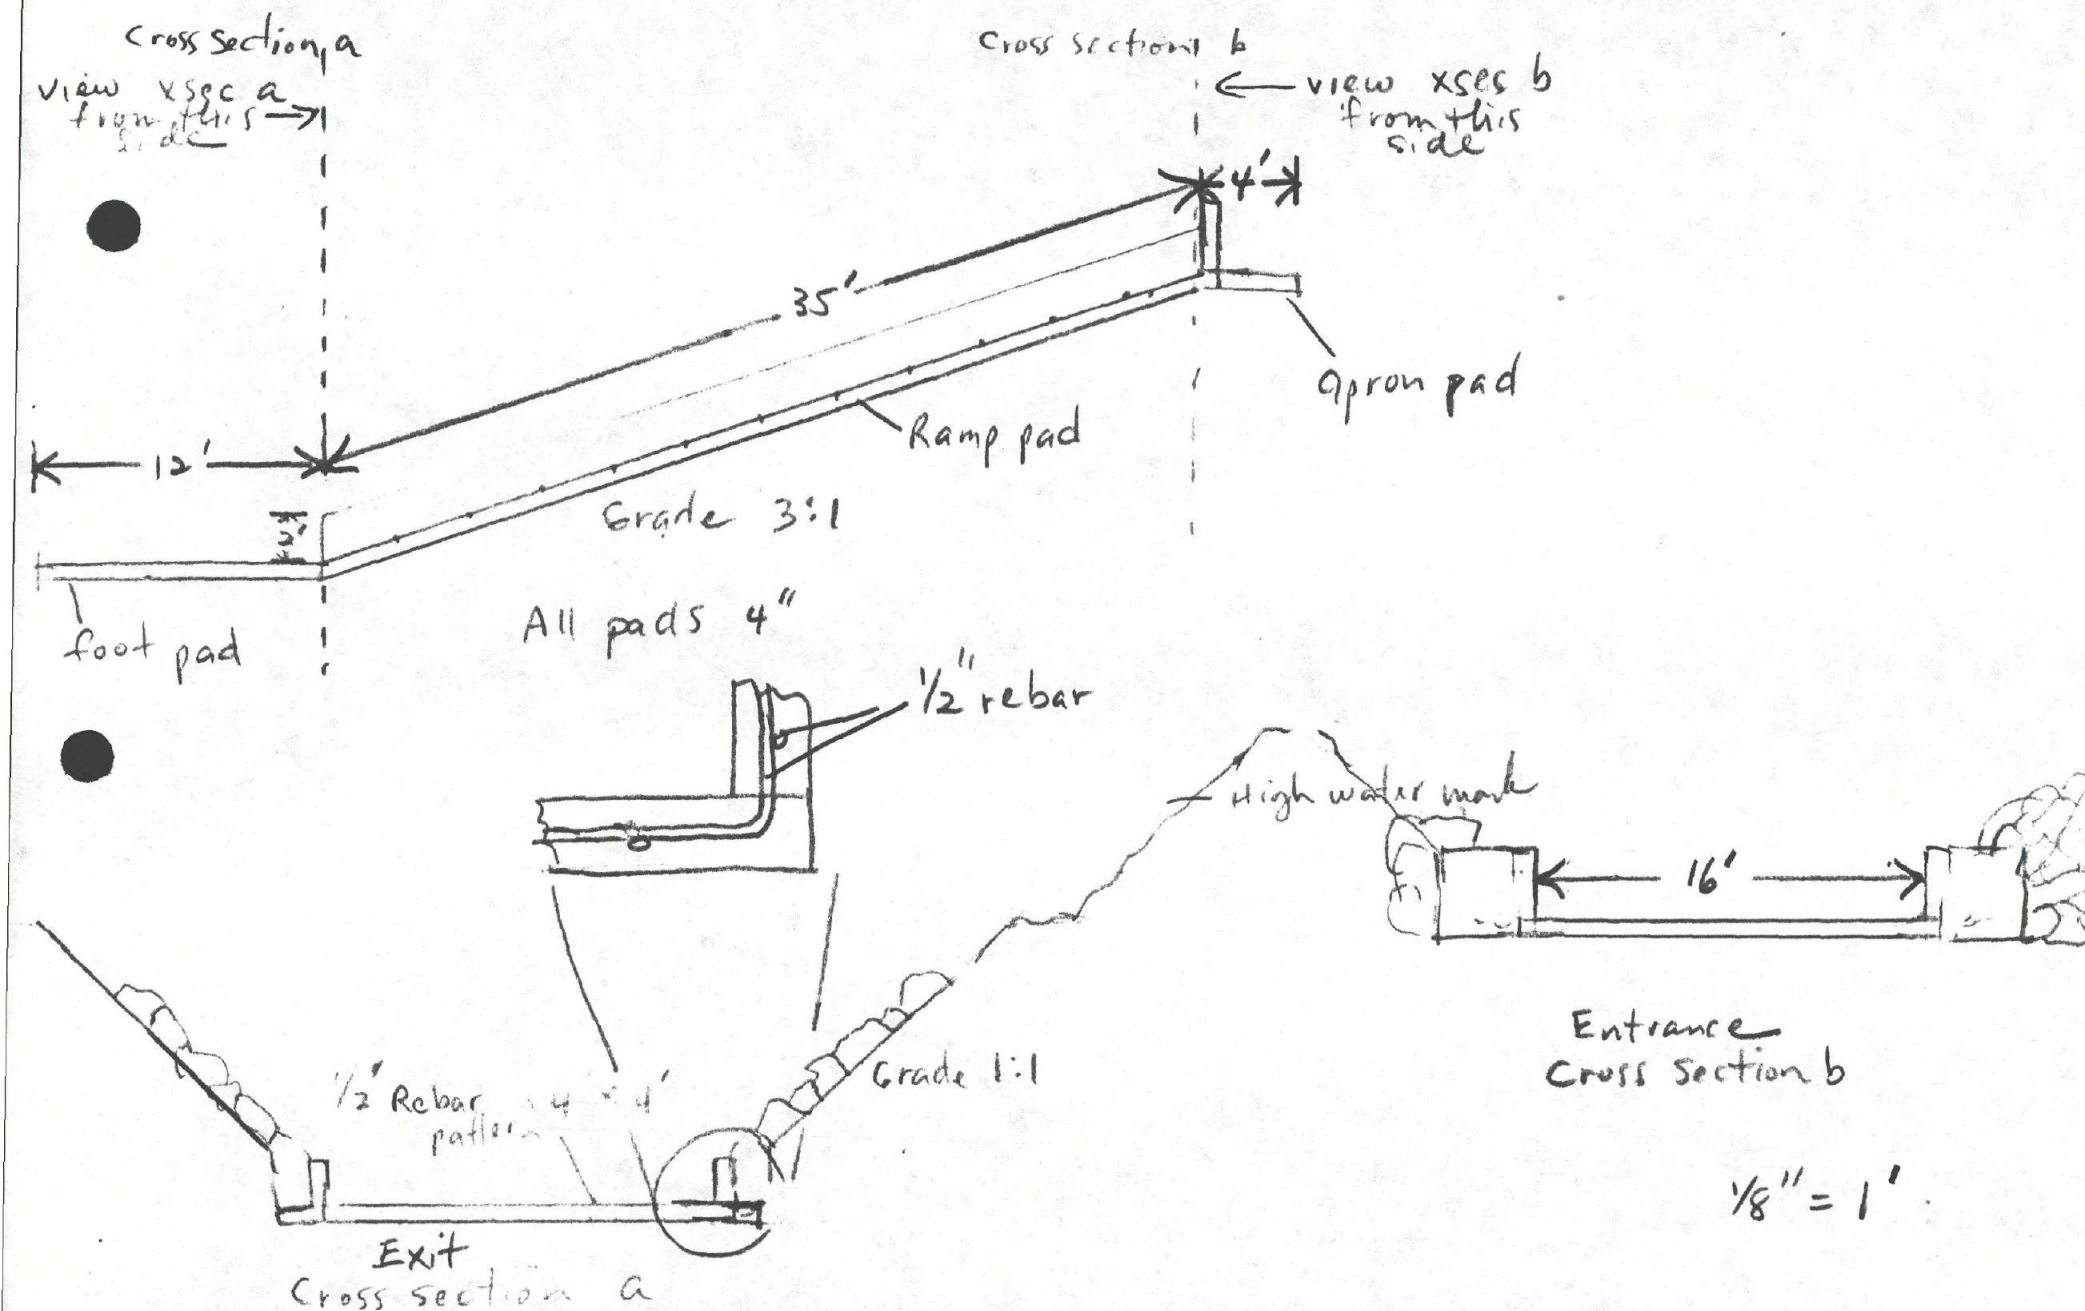
Inlet Spillway to Gravel/Debris Collection Pond

Outlet Spillway from Gravel/Debris Collection Pond

The inlet spillway would be constructed of reinforced concrete with a four by twenty foot apron pad on top. A sixteen foot wide ramp, thirty-five feet long with a 1:3 incline, would have a two foot concrete wall down either side to hold the rip rap armor that protects the 1:1 sides. The foot would be a twelve by twenty foot reinforced concrete pad. All concrete pads are four inches in depth. Both the entrance and the foot would be armored with rip rap.

The outlet spillway would be constructed of 1:1 sides armored with rip rap. It would be twenty feet wide at the depth of the natural stream bed. The outlet spillway would be oriented to send the water back into Davis Creek with no turns as is allowed by the natural configuration of the stream.

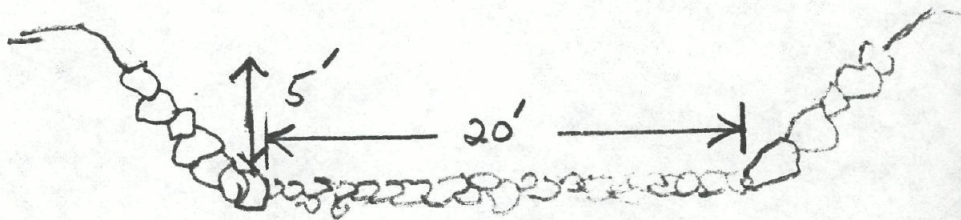
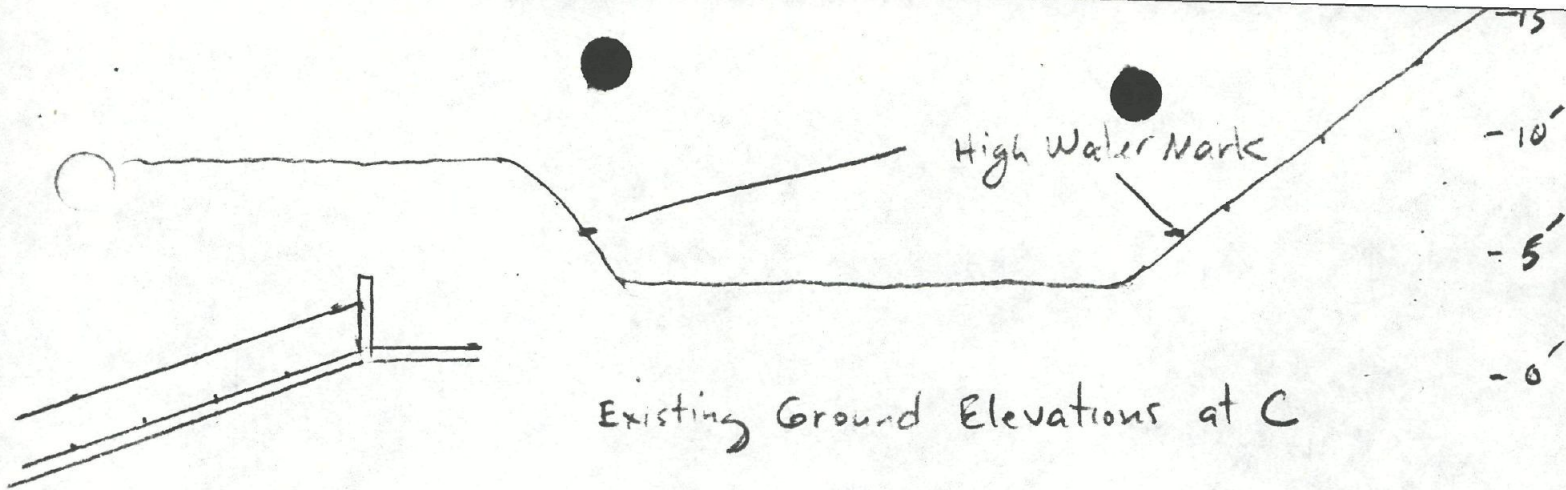
Cross section C

Existing Ground Elevations at C

Actual elevation
of inlet spillway in relation
to existing ground elevations

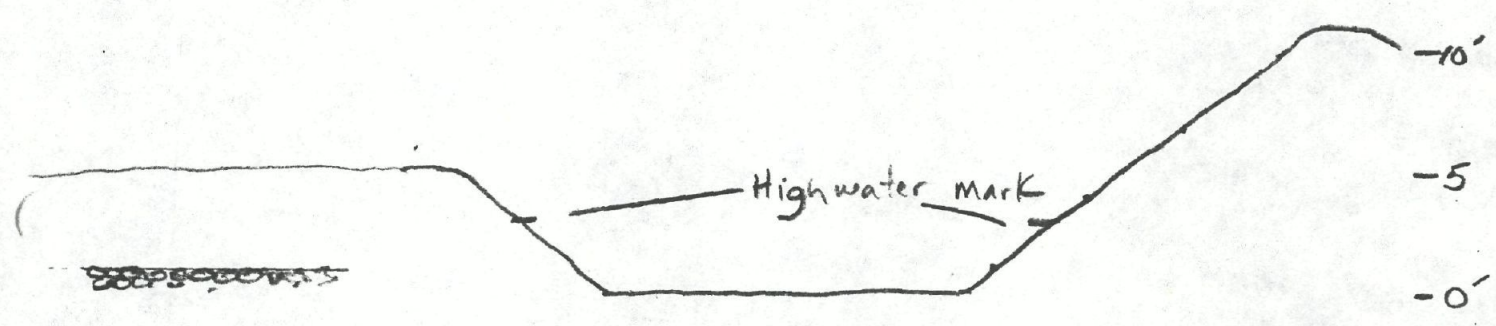
Existing Ground Elevation at B

Actual elevation
of outlet spillway
in relation to existing
ground elevations

scale $\frac{1}{8}'' = 1'$
